Project Name: CV2956 Colney Hatch Lane N10
Project Description: CCTV survey of below ground drainage
Project Number: CV2956
Project Date: 13/02/2019
Inspection Standard: MSCC5 Sewers & Drainage GB (SRM5 Scoring)

SUMMARY

As arranged, we have attended the above address to carry out a CCTV survey of all the accessible below ground drainage to prove route, connectivity and condition. It would appear that there are 2 No. separate systems of which only the foul water was accessible via manhole chambers. We did manage to survey a single surface water run from a newer UPVC gully outlet, as shown on the drawing (G 04). The remainder of the gullies are Vitrified Clay and have no rodding eye access points so survey works were not possible. The 2 No. side walls of manhole chamber MH 01 have bowed, and this is most likely to have been caused by tree roots. Below is a brief description on each of the surveyed sections.

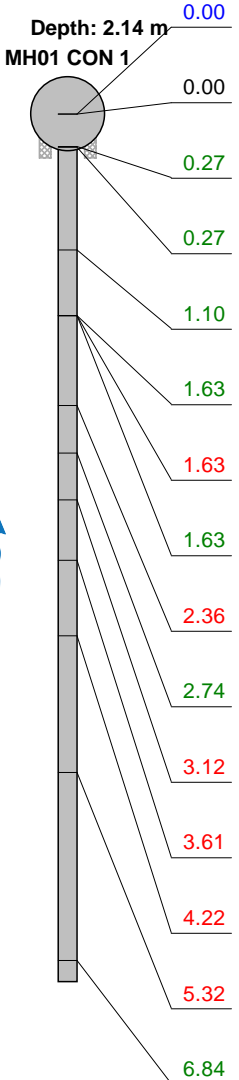
MH01 CON 1

S1 - Surveyed upstream from MH 01 Connection 1 to Gully G 01 at 17.52 metres. Multiple structural defects have been noted throughout this drainage run, fractures and cracks, and as such they will require remedial works. Both fractures and cracks can allow water loss from a drainage system.

0.27	DEZ	Attached deposits, other, from 01 to 05 o'clock, 5 % cross-sectional area loss, scale: scale	00:00:46		4
		0.27	DEZ	Attached deposits, other from 7 o'clock to 11 o'clock, 5% cross-sectional area loss: Scale			4

1.10	RFJ	Roots, fine at joint	00:01:29		2
		1.63	RTJ	Roots, tap at joint			4
		1.63	CCJ	Crack, circumferential at joint from 1 o'clock to 5 o'clock			2 / 2

1.63	RFJ	Roots, fine at joint	00:02:34		2
		2.36	CCJ	Crack, circumferential at joint, from 01 to 06 o'clock	00:03:09		2 / 2
		2.74	DEZ	Attached deposits, other from 1 o'clock to 3 o'clock, 5% cross-sectional area loss: Scale			4

3.12	FCJ	Fracture, circumferential at joint from 7 o'clock to 9 o'clock			3 / 2
		3.61	CCJ	Crack, circumferential at joint from 3 o'clock to 9 o'clock	00:04:54		2 / 2

4.22	CCJ	Crack, circumferential at joint from 12 o'clock to 2 o'clock			2 / 2
		5.32	CCJ	Crack, circumferential at joint, from 04 to 11 o'clock	00:07:01		2 / 2

Substantial remedial works will be required to Sections S1, S4/5, S6, S7 and S8.

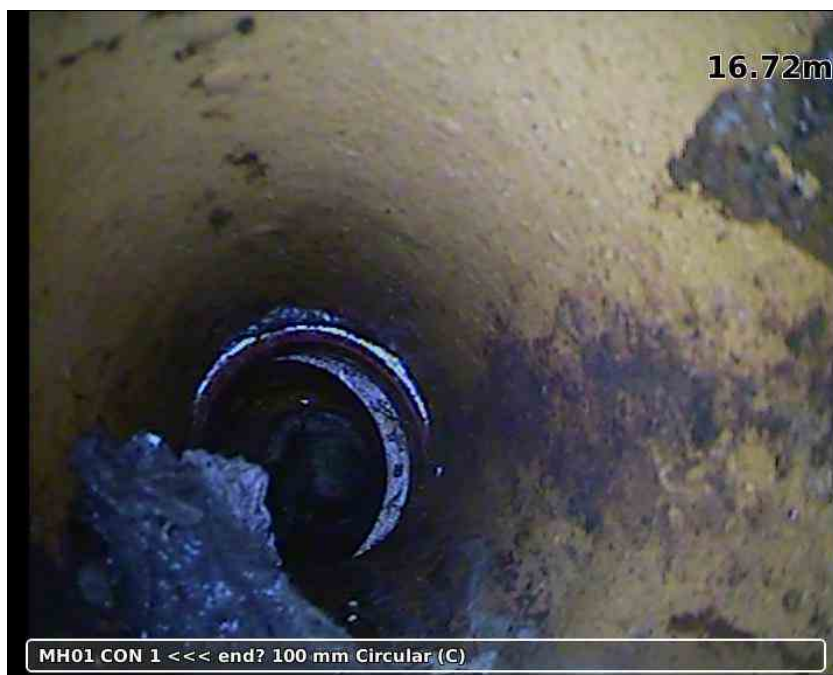
20190213-101032-snap0000.jpg, 00:20:58, 16.72 m
General photograph taken at this point

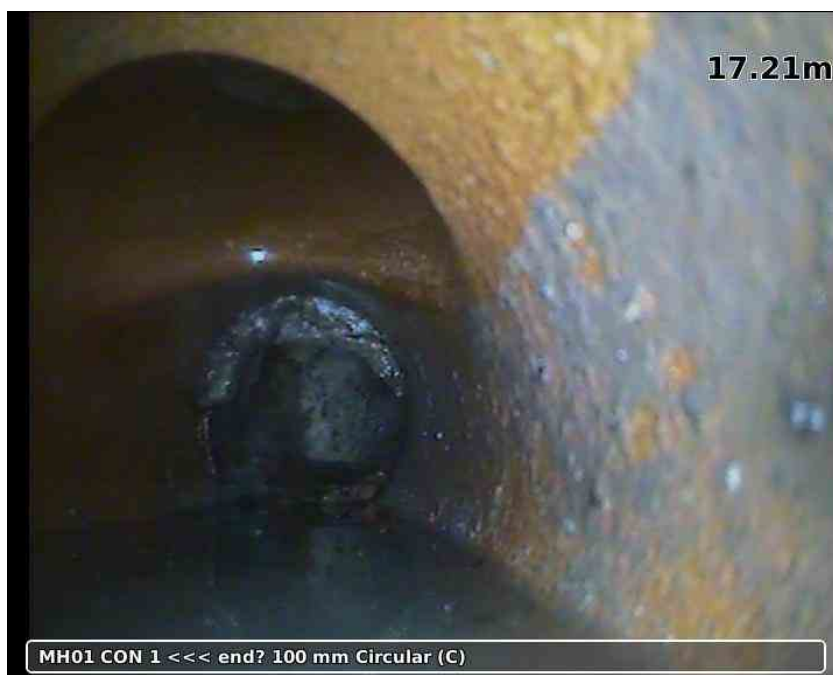
20190213-101032-snap0001.jpg, 00:25:41, 17.21 m
General photograph taken at this point

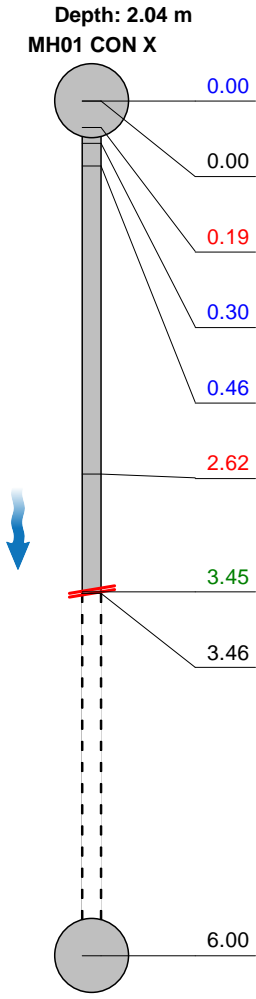
S2/S3 - Surveyed downstream from MH 01 to the main sewer where the survey had to be terminated at 3.46 metres due to 30% debris attached deposits, which we were unable to remove by jetting works. The fracture in the rodding eye is not part of the drainage system and can be left in it's present condition. A single crack was noted at 2.62 metres which could be left in it's present condition, as this is nowhere near the property in question. Although our camera was unable to pass the deposits, the system was not blocked and the deposits are not affecting the flow of the system. However it would be advisable to have the deposits removed. We suspect that the deposits are just past the boundary line of the property, which would mean that this would become the responsibility of the local water authority to attend to, if left and this proved a problem in the future.

<table><tr> <td style="width: 10%;">0.00</td> <td style="width: 10%;">MH</td> <td style="width: 40%;">Start node type, manhole, reference number: MH01 CON X</td> <td style="width: 10%;">00:00:02</td> <td style="width: 10%;"></td> <td style="width: 10%;"></td> <td style="width: 10%;"></td> </tr><tr> <td>0.19</td> <td>FC</td> <td>Fracture, circumferential from 1 o'clock to 6 o'clock: In rodding eye</td> <td>00:00:20</td> <td></td> <td></td> <td>3 / 2</td> </tr><tr> <td>2.62</td> <td>CCJ</td> <td>Crack, circumferential at joint, from 02 to 05 o'clock</td> <td>00:01:26</td> <td></td> <td></td> <td>2 / 2</td> </tr><tr> <td>3.45</td> <td>DEZ</td> <td>Attached deposits, other from 3 o'clock to 6 o'clock, 30% cross-sectional area loss: Unknown</td> <td></td> <td></td> <td></td> <td>4</td> </tr><tr> <td>3.46</td> <td>SA</td> <td>Survey abandoned: Unable to pass</td> <td>00:02:39</td> <td></td> <td></td> <td></td> </tr></table>

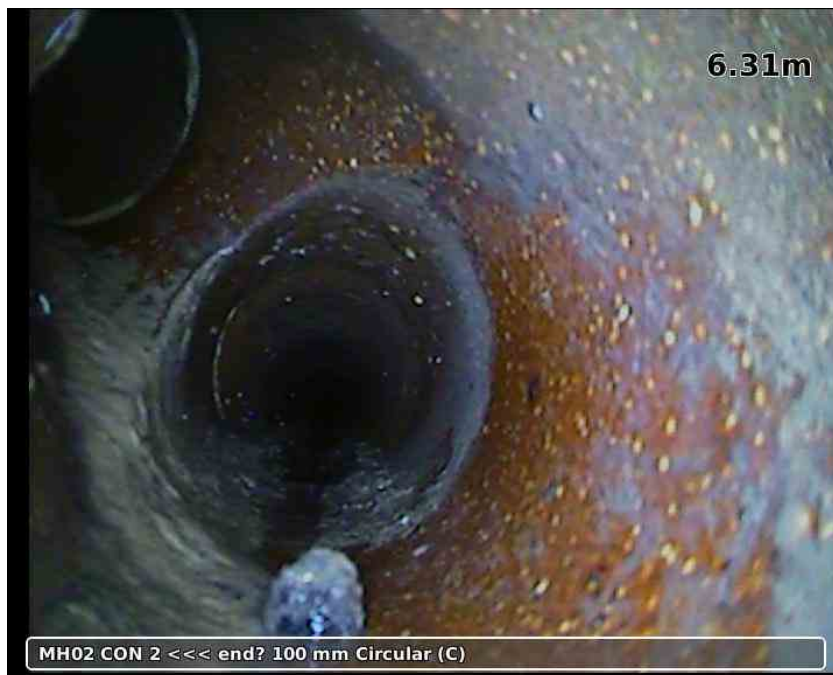
20190213-121924-snap0000.jpg, 00:03:13, 6.31 m
General photograph taken at this point

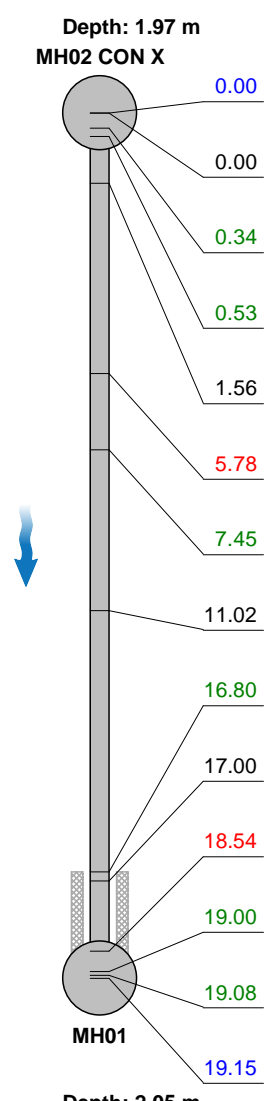
S6 - Surveyed downstream from MH 02 to MH 01 at 19.15 metres. 1 No. crack and 1 No. fracture have been noted which are classified as structural defects and should be remedied. Some minor root infiltration and minor scale deposits have also been noted.

<table><tr> <td style="text-align: right;">0.00</td> <td style="text-align: left;">MH</td> <td>Start node type, manhole, reference number: MH02 CON X</td> <td style="text-align: right;">00:00:03</td> <td></td> <td></td> <td></td> </tr><tr> <td style="text-align: right;">0.53</td> <td style="text-align: left;">DES</td> <td>Settled deposits, fine, 20 % cross-sectional area loss</td> <td style="text-align: right;">00:00:21</td> <td></td> <td></td> <td style="text-align: center;">4</td> </tr><tr> <td style="text-align: right;">5.78</td> <td style="text-align: left;">CCJ</td> <td>Crack, circumferential at joint, from 08 to 12 o'clock</td> <td style="text-align: right;">00:01:28</td> <td></td> <td></td> <td style="text-align: center;">2 / 2</td> </tr><tr> <td style="text-align: right;">7.45</td> <td style="text-align: left;">RFJ</td> <td>Roots, fine at joint</td> <td style="text-align: right;">00:00:05</td> <td></td> <td></td> <td style="text-align: center;">2</td> </tr><tr> <td style="text-align: right;">18.54</td> <td style="text-align: left;">FCJ</td> <td>Fracture, circumferential at joint from 9 o'clock to 3 o'clock</td> <td style="text-align: right;">00:05:44</td> <td></td> <td></td> <td style="text-align: center;">3 / 2</td> </tr></table>

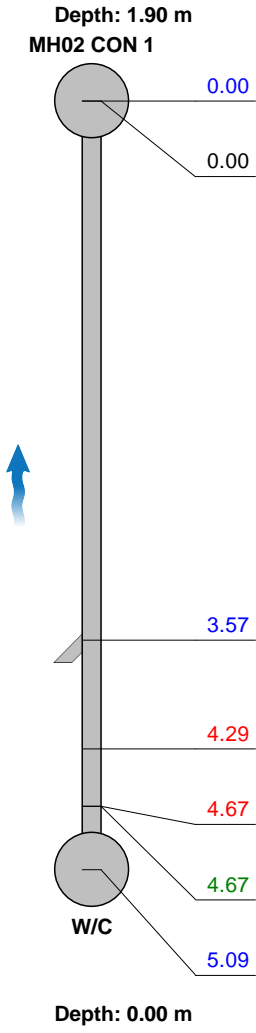
S7 - Surveyed upstream from MH 02 Connection 1 to a WC at 5.09 metres. 2 No. cracks have been noted, which will require remedial works.

<table><tr> <td style="width: 10%;">0.00</td> <td style="width: 10%;">MH</td> <td style="width: 40%;">Start node type, manhole, reference number: MH02 CON 1</td> <td style="width: 10%;">00:00:03</td> <td></td> <td></td> <td></td> </tr><tr> <td style="width: 10%;">4.29</td> <td style="width: 10%;">CC</td> <td style="width: 40%;">Crack, circumferential from 7 o'clock to 3 o'clock</td> <td style="width: 10%;">00:01:16</td> <td></td> <td></td> <td style="text-align: center;">2 / 2</td> </tr><tr> <td style="width: 10%;">4.67</td> <td style="width: 10%;">CC</td> <td style="width: 40%;">Crack, circumferential from 5 o'clock to 9 o'clock</td> <td style="width: 10%;">00:01:16</td> <td></td> <td></td> <td style="text-align: center;">2 / 2</td> </tr></table>

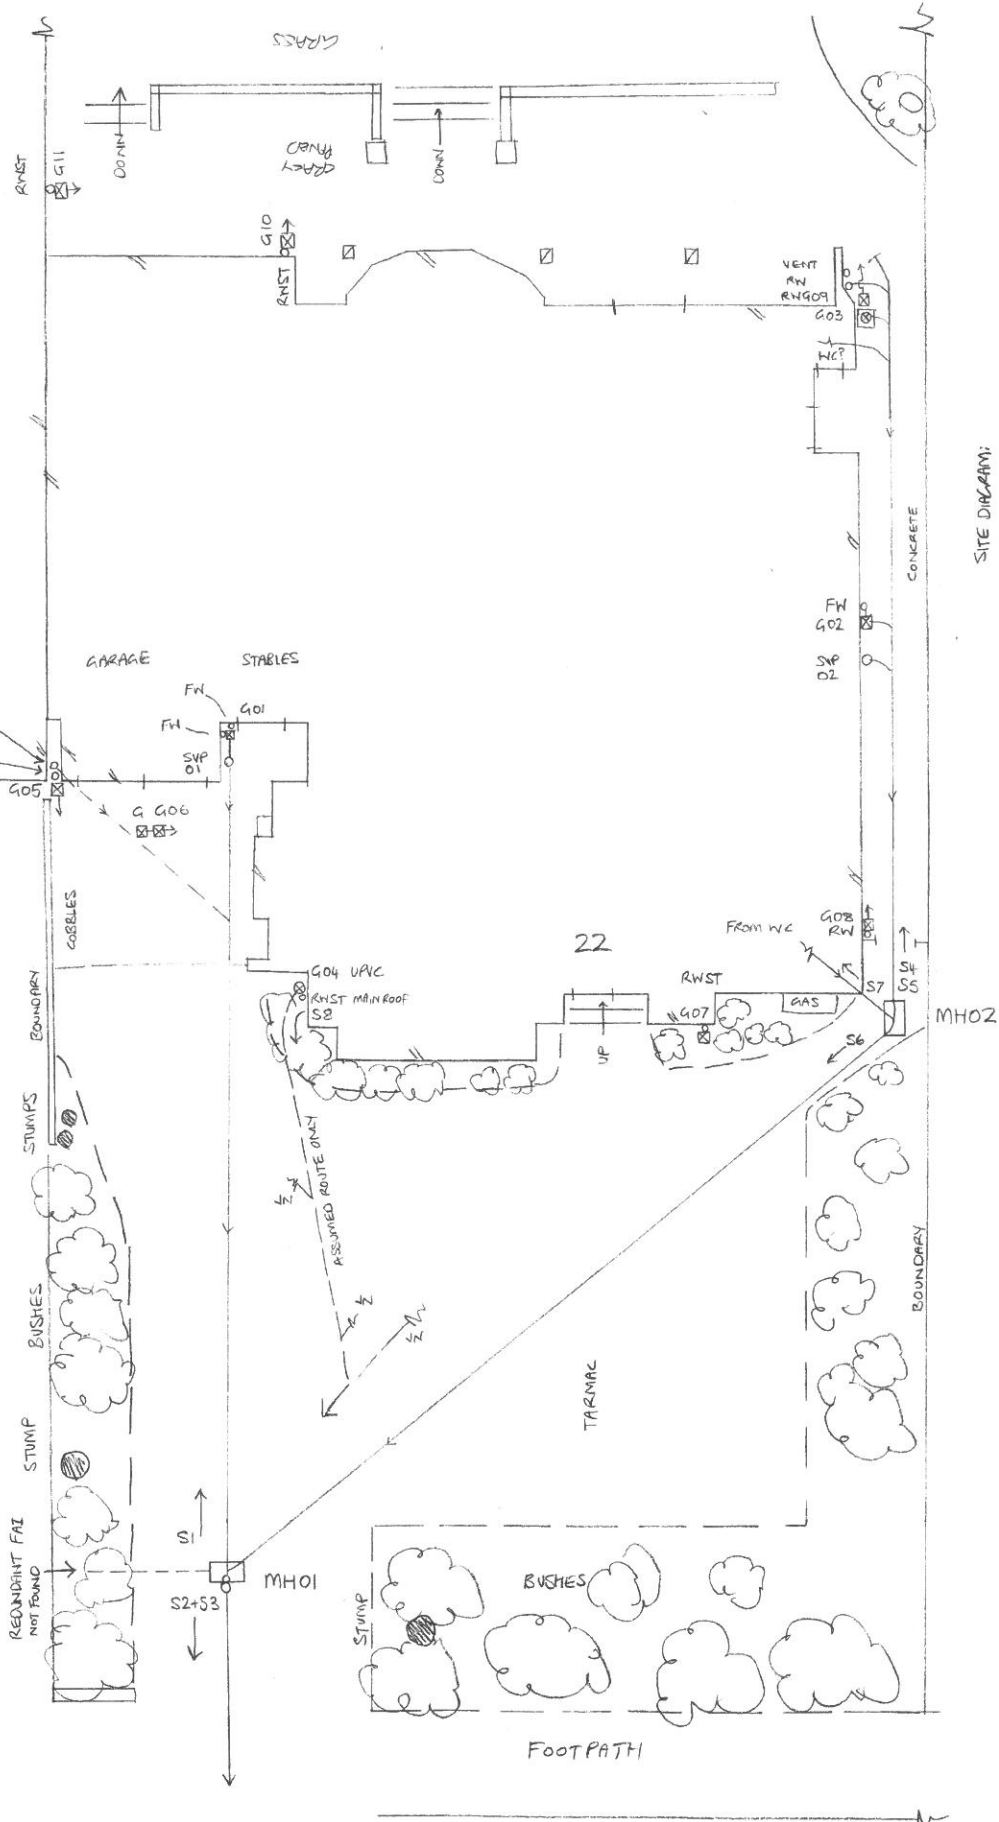
SITE DIAGRAM:

100MM CI STACK OPEN AT HIGH LEVEL NOW REDUNDANT. ASSUMED THIS GOES TO SUNCTION @ 1/4M APPROX ON S1

* MHO1 WALLS BOUNDED TO LEFT + RIGHT HAND SIDE
