Project Name: CV2956 Colney Hatch Lane N10
Project Description: CCTV survey of below ground drainage
Project Number: CV2956
Project Date: 13/02/2019
Inspection Standard: MSCC5 Sewers & Drainage GB (SRM5 Scoring)

SUMMARY

As arranged, we have attended the above address to carry out a CCTV survey of all the accessible below ground drainage to prove route, connectivity and condition. It would appear that there are 2 No. separate systems of which only the foul water was accessible via manhole chambers. We did manage to survey a single surface water run from a newer UPVC gully outlet, as shown on the drawing (G 04). The remainder of the gullies are Vitrified Clay and have no rodding eye access points so survey works were not possible. The 2 No. side walls of manhole chamber MH 01 have bowed, and this is most likely to have been caused by tree roots. Below is a brief description on each of the surveyed sections.

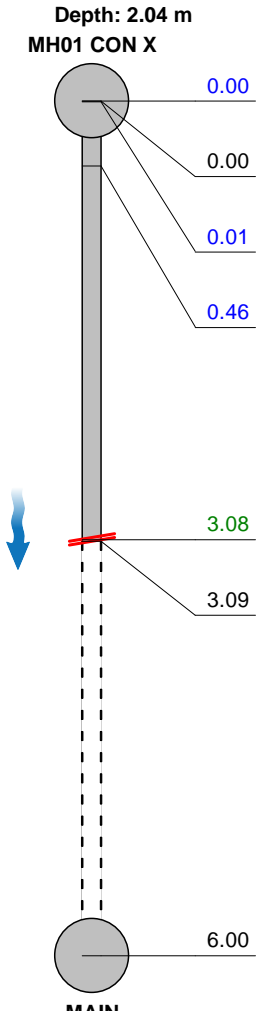
Scale:	1:53	Position [m]	Code	Observation	MPEG	Photo	Grade

0.00	MH	Start node type, manhole, reference number: MH01 CON X	00:00:02		
		0.00	WL	Water level, 5 % of the vertical dimension	00:00:02		
		0.01	JN	Junction, at 06 o'clock, diameter: 150 mm	00:00:09		
		0.46	SC	Pipe size changes, new size(s)	00:00:29		
		3.08	DEZ	Attached deposits, other from 3 o'clock to 7 o'clock, 30% cross-sectional area loss: Unknown	00:01:17		4
		3.09	SA	Survey abandoned: Unable to pass	00:03:07		
		6.00		End of pipe

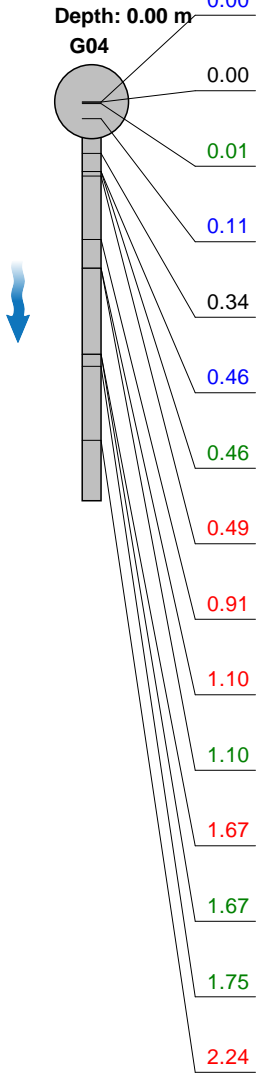
1.10	RFJ	Roots, fine at joint	00:17:44		2
		1.67	FCJ	Fracture, circumferential at joint from 7 o'clock to 5 o'clock	00:17:44		3 / 2
		1.67	RFJ	Roots, fine at joint	00:17:44		2

1.75	LL	Line deviates left: Half	00:17:44		
		2.24	CCJ	Crack, circumferential at joint from 9 o'clock to 2 o'clock	00:17:44		2 / 2

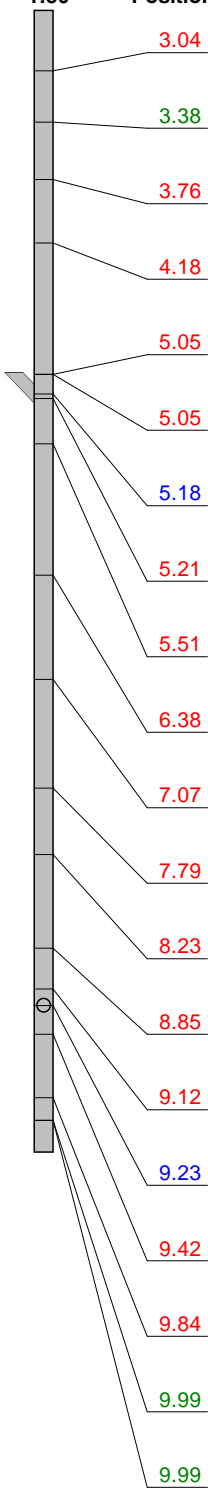
Scale: 1:50	Position [m]	Code	Observation	MPEG	Photo	Grade

3.04	FCJ	Fracture, circumferential at joint from 9 o'clock to 3 o'clock	00:17:44		3 / 2
	3.38	RF	Roots, fine	00:17:44		2

3.76	CC	Crack, circumferential from 12 o'clock to 12 o'clock	00:17:44		2 / 2
	4.18	CC	Crack, circumferential from 12 o'clock to 12 o'clock	00:17:44		2 / 2
